NASA-DoD Lead-Free Electronics Project

Joint Test Report - Final

December 2011

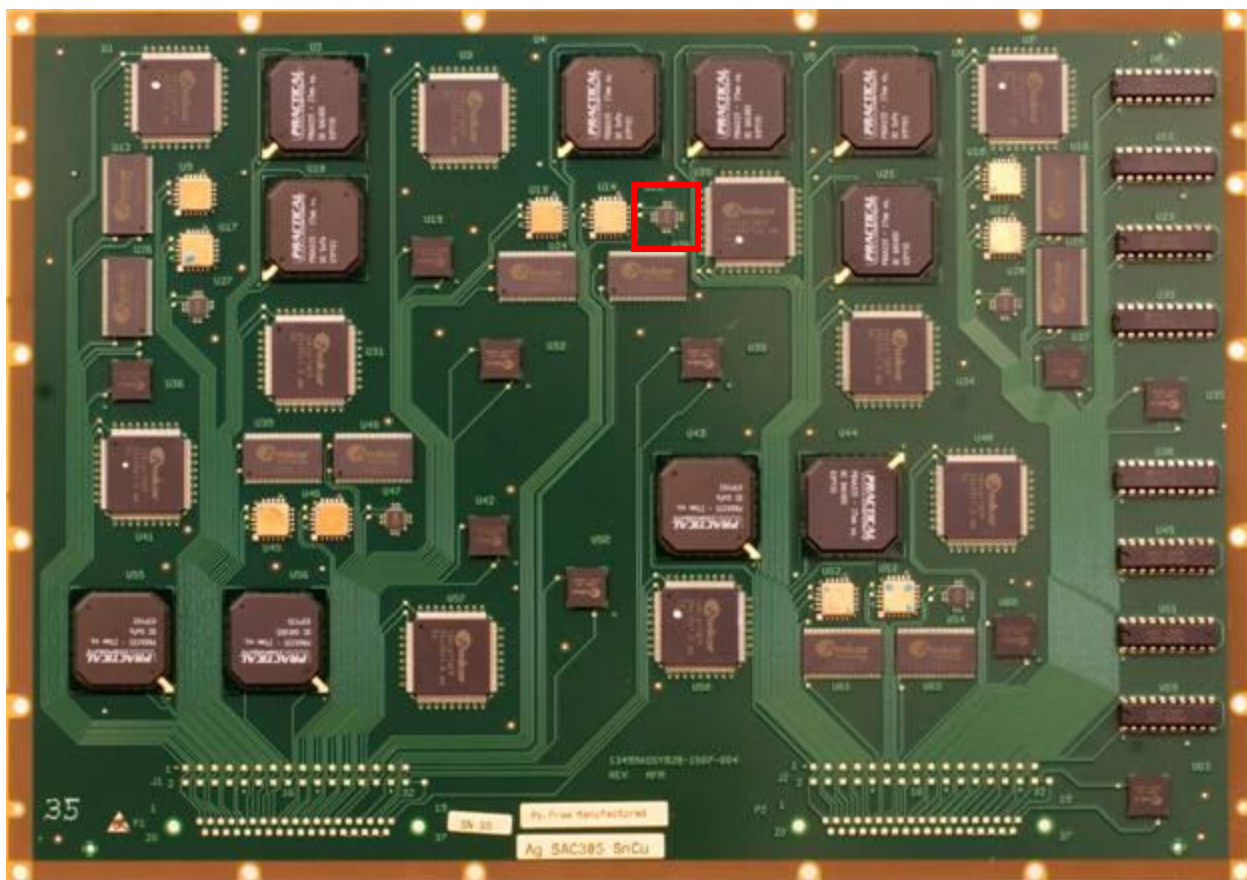
Figure 6 - Quad Flat No leads (QFN), Component Location U15

Component location U15, a QFN, is missing a wire trace, Figure 6. During drafting, the trace was not included in the test vehicles drawing, Figure 7. Test data cannot be collected for this component unless a jumper wire is used in-place of the missing trace. Jumper wires were used for the thermal cycle test vehicles. For vibration, drop, mechanical shock and combined environments testing, it was determined that a jumper wire is not feasible. For the NSWC Crane rework test vehicles, QFN U15 is an active rework component. For drop and vibration testing, a jumper wire was attached to each U15 location to permit collection of test data (see Figure 8).

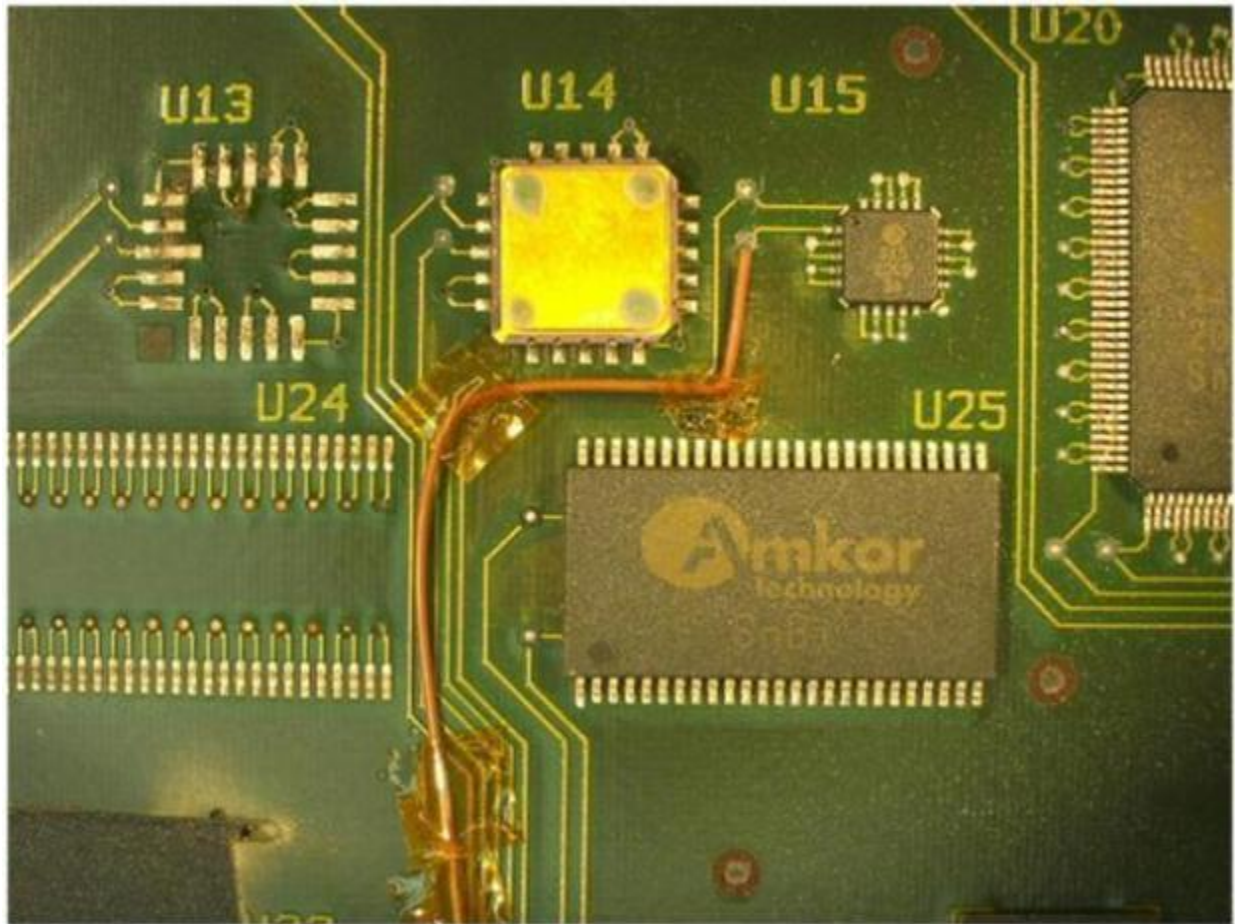
Figure 8 - Jumper Wire Attached to U15 Location to Permit Collection of Test Data

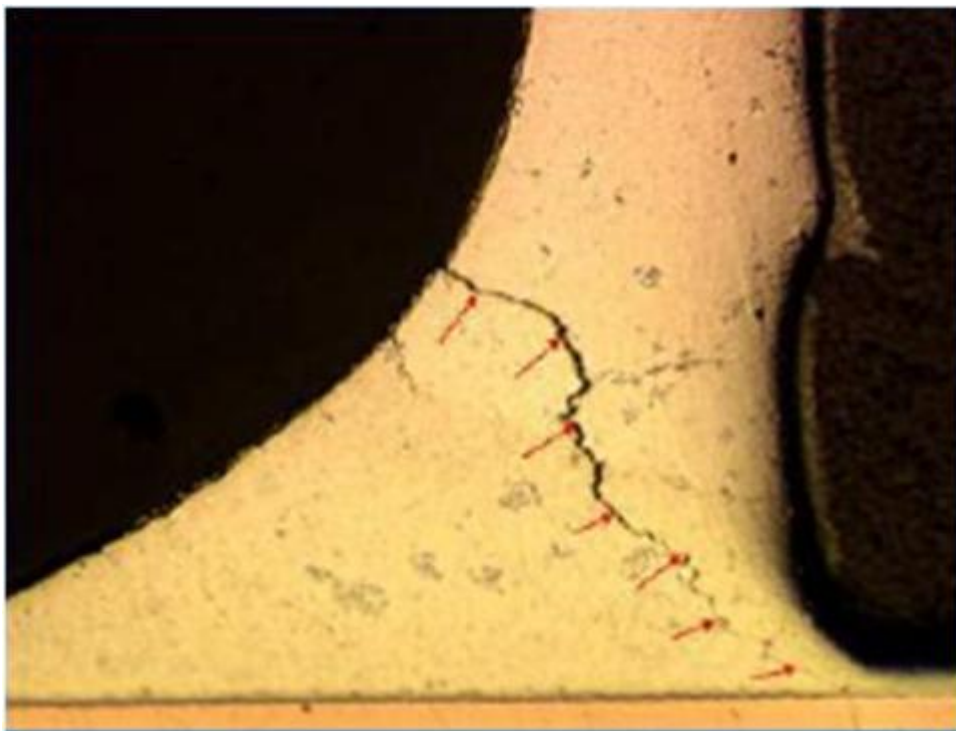
Figure 17 - SN63 U52, Left Side Pad

All of the tested CLCC-20s had SAC305 component finish. None of these solder joints were reworked. Solder cracks we observed around every solder joint. The cross sections of all CCLC-20 packages were performed on corner pads. Each cross section revealed cracking across the length of the solder, see Figure 17. SN67 also showed voiding, in this case the crack traveled along the void, see Figure 18.

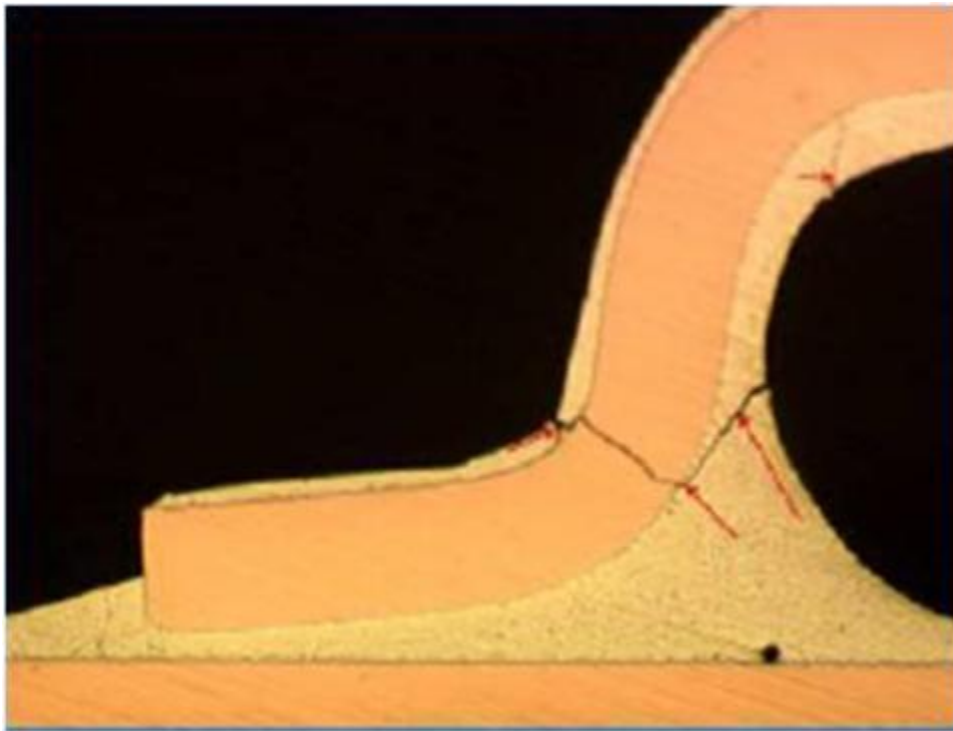
Figure 21 - SN63 U41. Left Lead

Cross-sectioning revealed cracks in the actual copper leads of the TQFP-144 packages. This damage was observed only on parts which were not reworked and therefore the solder joint was Pb-free. This is to be expected as the Pb-free solder is stiffer than the SnPb solder and transfers the stress to the weaker copper leads. Figure 21 and Figure 22 illustrate TQFP-144 packages which were not reworked and therefore contain only Pb-free solders.

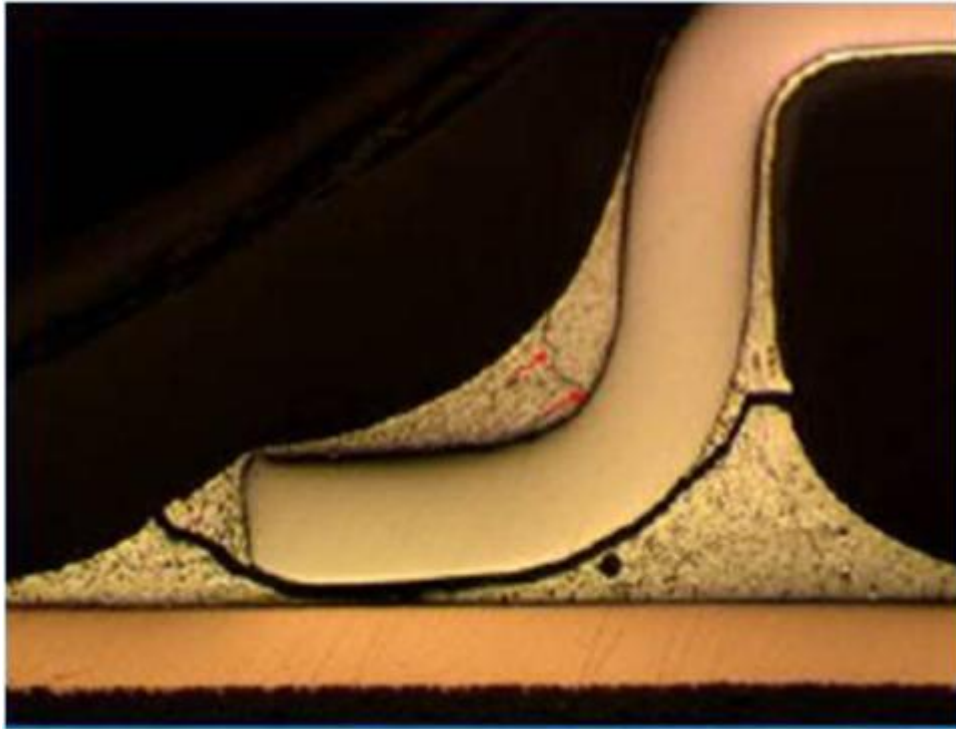
Figure 29 - SN63 U16, Left Lead

SN63 U16 (Figure 29) and SN68 U29 (Figure 30) were both re-worked twice with SnPb solder. SN63 U16 is finished with SnBi and SN68 U29 is finished with Sn. The SnBi part experienced extensive solder cracking through-out. The Sn finished part experienced solder cracking at one side of the component.

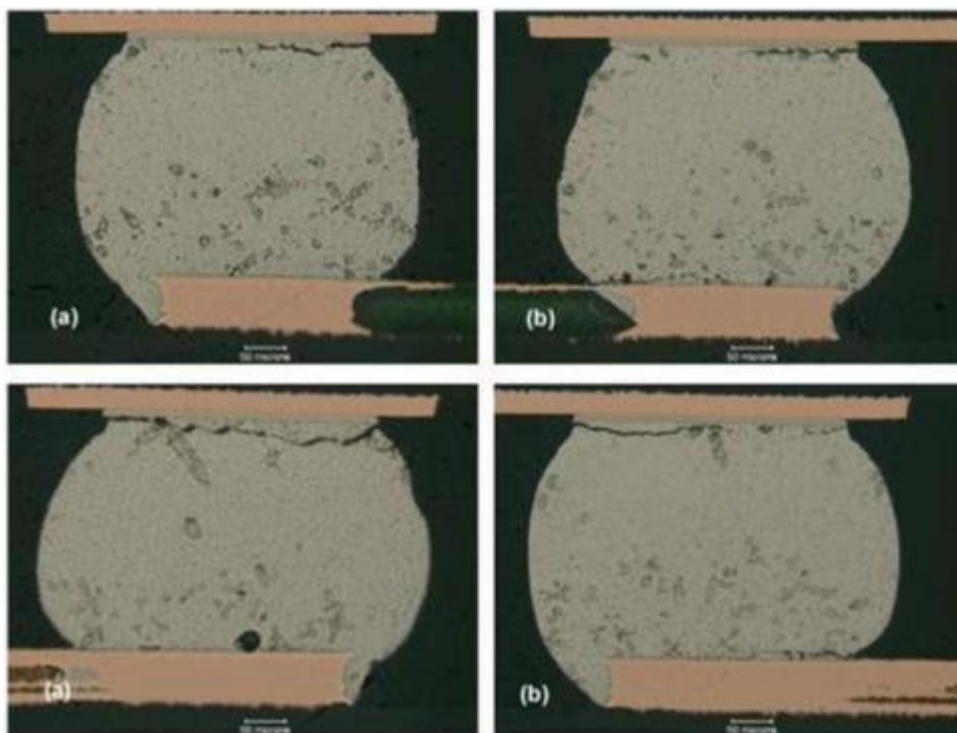
Figure 41 - Test Vehicle 34 – CSP U33

The combination of SAC305 solder/SAC105 balls generally performed as well as the SnPb/SnPb controls in mechanical shock. Microsections made at the end of the test showed that the corner solder joints failed first. The SnPb/SnPb solder joints formed cracks primarily on the component side (Figure 41). The SAC305/SAC105 solder joints formed cracks primarily on the component side and also showed evidence of pad cratering (Figure 42).

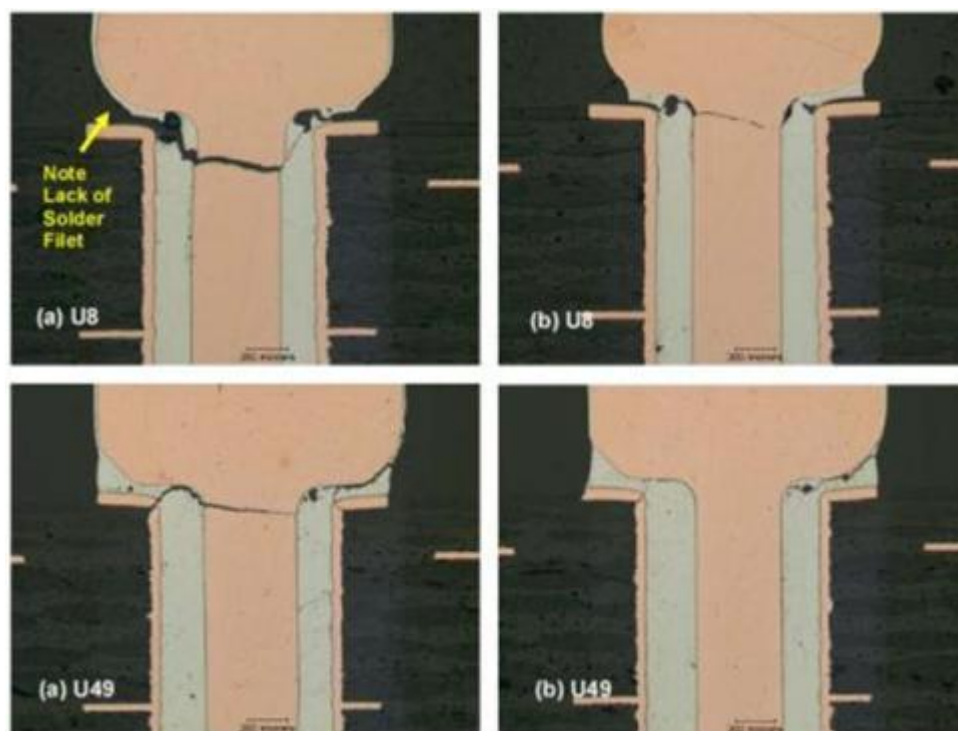
The combination of SN100C solder/Sn component finish generally performed as well as the SnPb/SnPb controls in mechanical shock although some of the SN100C/Sn solder joints failed early. Microsections made at the end of the test showed that the corner solder joints failed before the other solder joints. The topside solder fillet would crack first followed by cracking of the lead where it necks down at the top of the PTH (Figure 43 and Figure 44).

Figure 44 - Test Vehicle 89 – PDIPs U8 and U49 (a) Corner Lead, (b) Lead Adjacent to Corner Lead (SN100C Solder/Sn Finish)

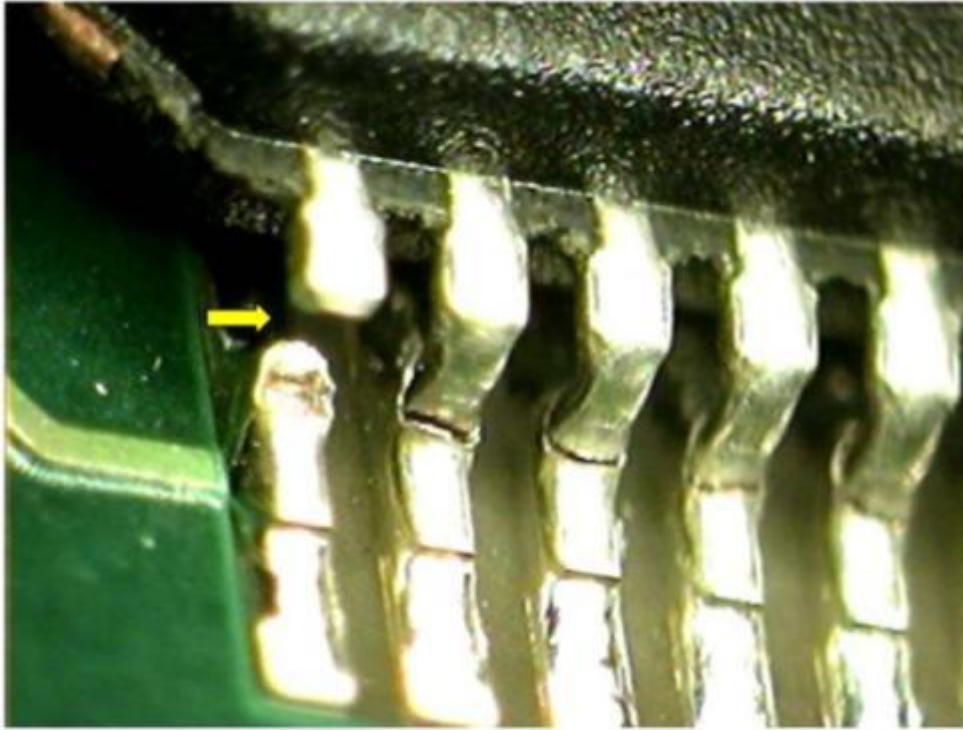
Most of the TQFP-144’s had broken and/or missing leads at the end of the test (Figure 48). Since most of the failures appeared to be due to broken leads, the scatter in the test data for all of the TQFP solder/finish combinations was small. SAC305/Sn was equivalent in performance to SnPb/Sn, SnPb/NiPdAu (on immersion Ag), and SnPb/NiPdAu (on ENIG). SAC305/NiPdAu was superior to the SnPb/Sn controls in performance.

Figure 48 - Test Vehicle 89 TQFP U3 (Cracked Leads, Missing Lead)

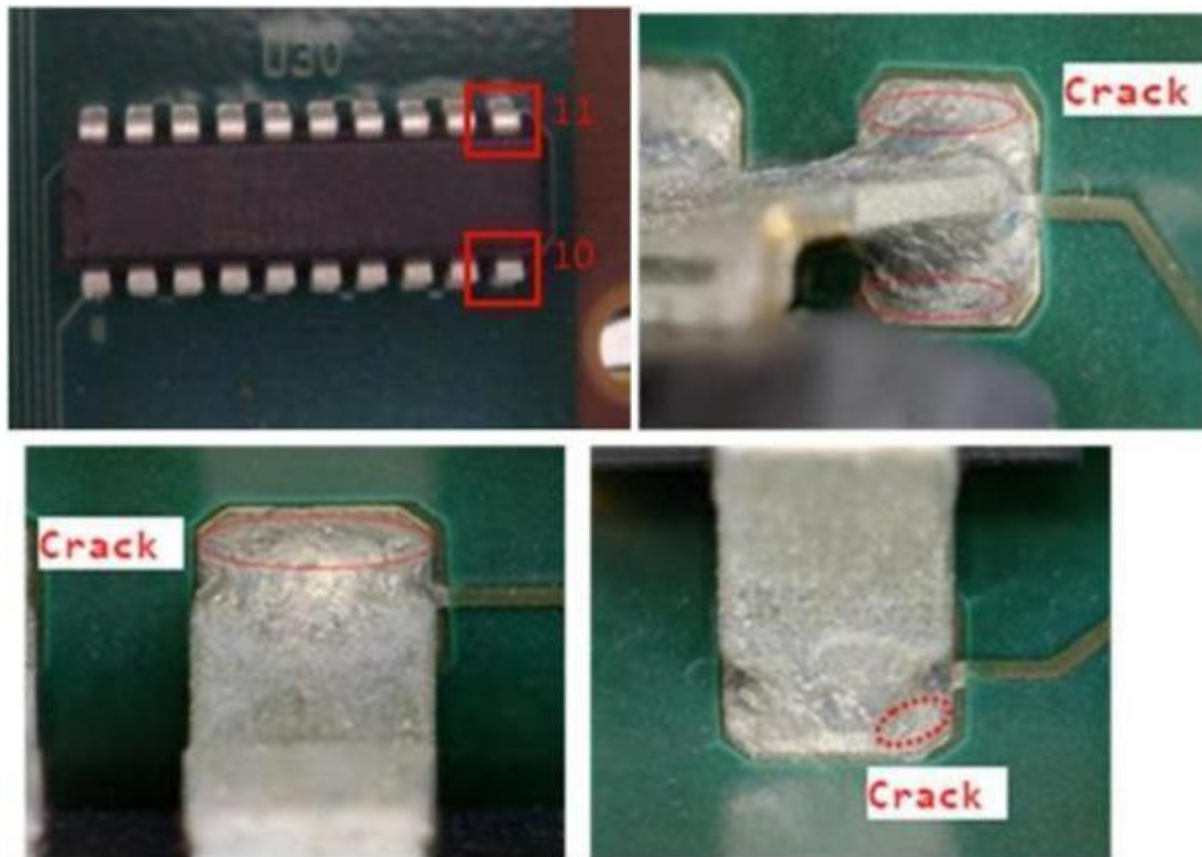
Figure 57 - TV23 U30; Optical Micrograph, PDIP-20

Component location U30 is a PDIP-20 from the SnPb manufactured (Batch C), soldered with SnPb on tin plated component finish. This component survived all 650 cycles of combined environments testing and it was surrounded by components that fell off during testing. Figure 57, the red boxes highlight the two leads that were magnified to indicate observed cracking in the solder joints. The image in the upper right is of lead 11, which indicates two areas with cracking. The image in the bottom left is the top portion of lead 11 and the bottom right image is of lead 10 showing a small crack near the pad. Crack has not caused an electrical failure, yet.

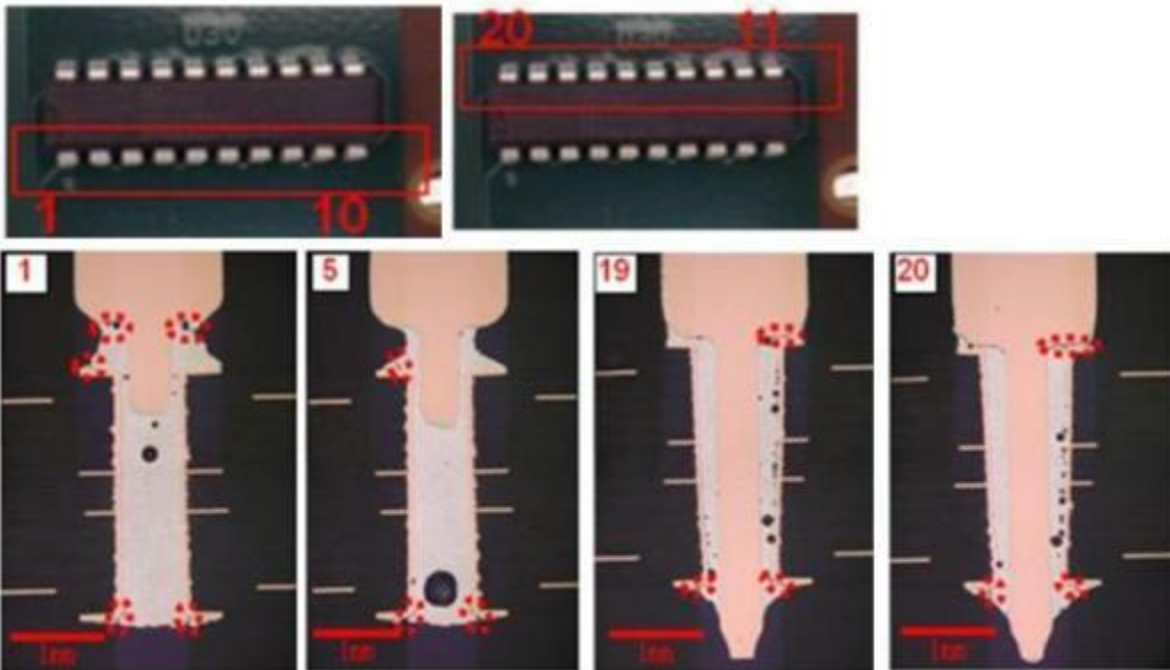
Figure 58 - TV23 U30; Cross-Sectional Micrographs of PDIP-20 Leads

Figure 58 shows cross-sectional micrographs of PDIP-20 leads where the two images on the top are indicating the lead numbering. The cross-sections of leads 1, 5, 19 and 20 were selected as an example of the leads that had large quantities of voids, relative to the other component leads. The dotted lines indicate solder cracks that were found; no break off solder was found during failure analysis.

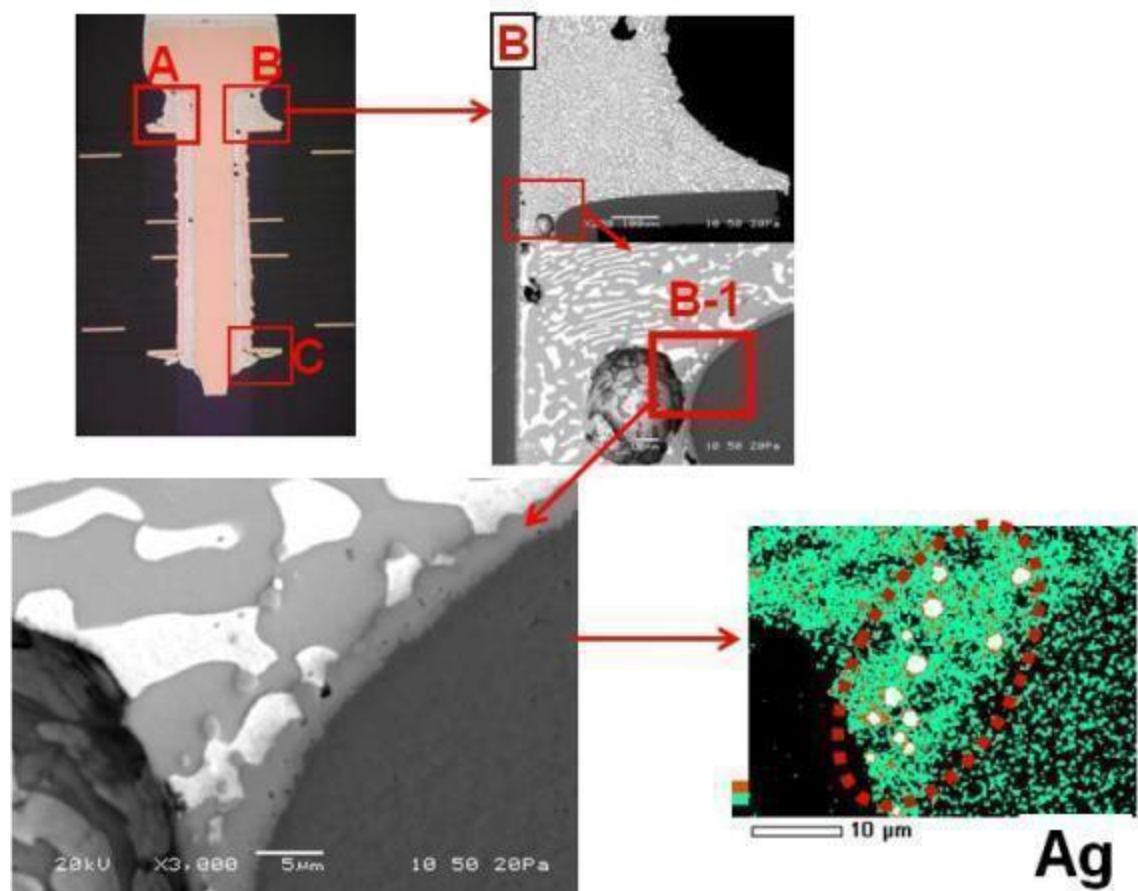
Figure 59 - TV23 U30; Micrographs, Lead 9 of PDIP-20

The micrographs in Figure 59 show progression of analysis for lead 9 of PDIP-20 component beginning with upper left and following the arrows to the image on the bottom right. This analysis found silver (bottom right) within the solder joint. The source of the silver may have been the immersion silver board finish.

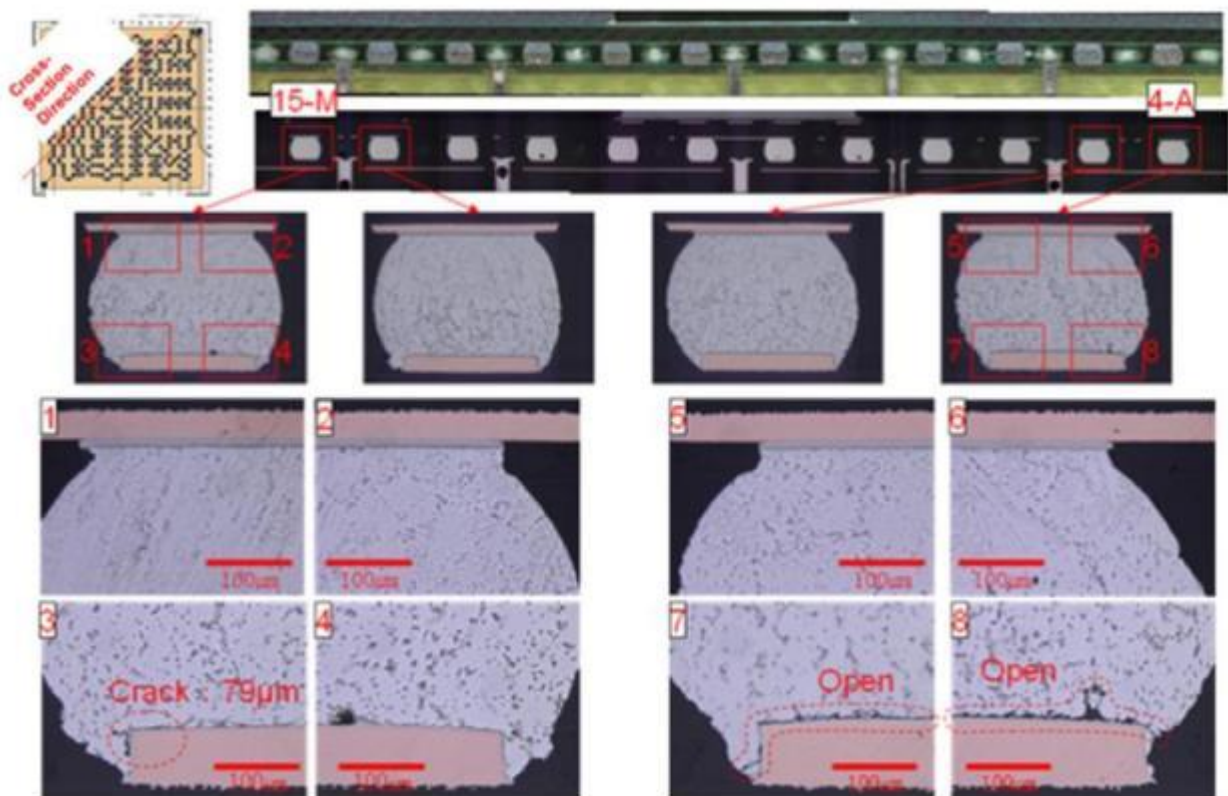
Figure 61 - TV23 U43; Cross-Sectional Micrographs

Cross-sectional micrographs in Figure 61 show different solder structure in lands on board (3, 4, 7, 8) and lands on component (1, 2, 5, 6). Cracking to open along land on board observed at 3-A.

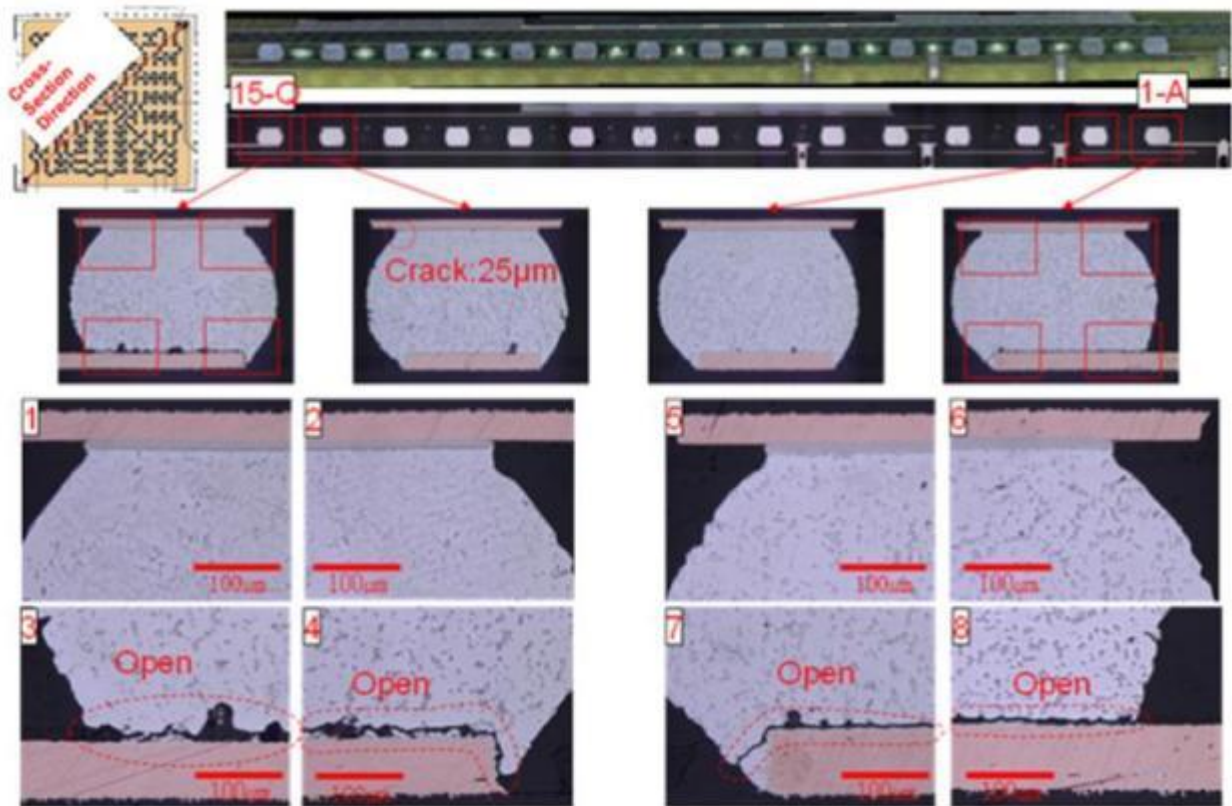
Figure 62 - TV23 U43; Cross-Sectional Micrographs

Cross-sectional micrographs in Figure 62 show different solder structure in lands on board (3, 4) and lands on component (1, 2). Cracking to open along land on board observed at 1-A and 15-Q.

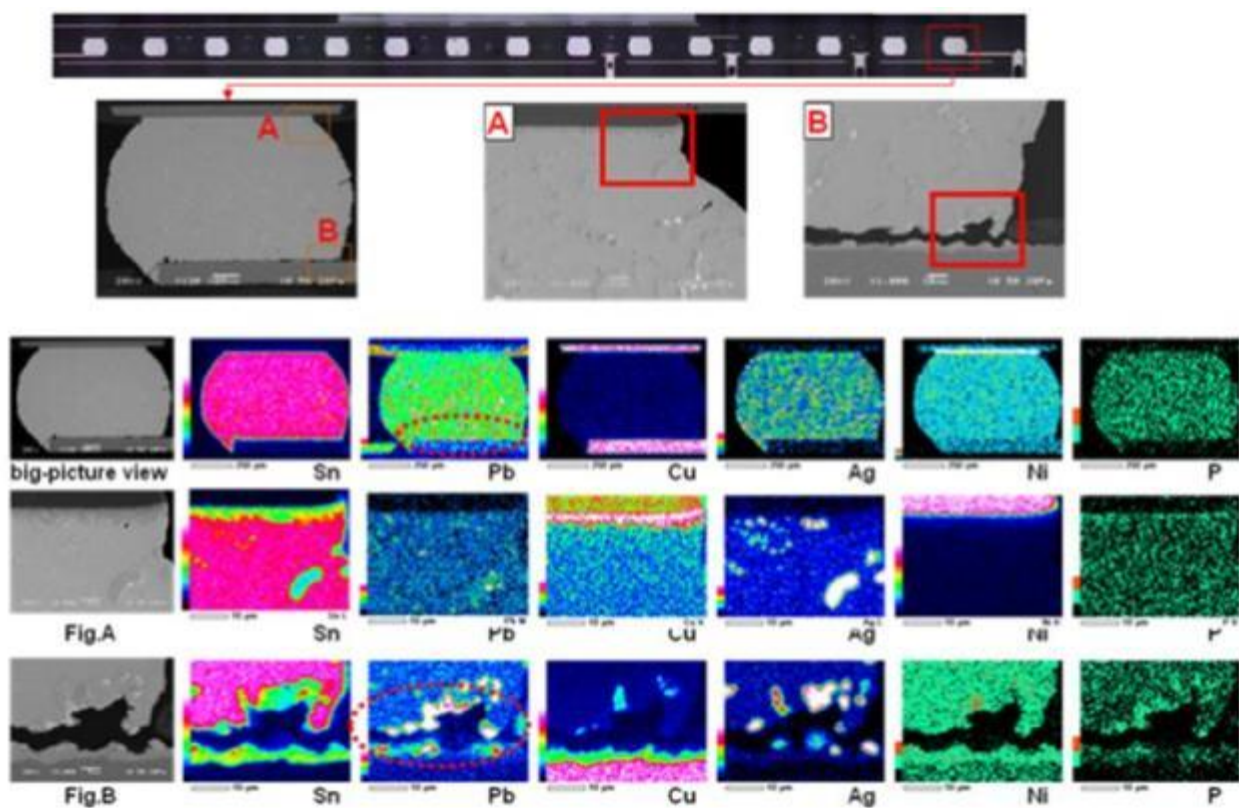
Figure 63 - TV23 U43; SEM Mapping

In Figure 63 SEM mapping shows segregation of Pb around land on board. Cracking found in the part Pb segregated.

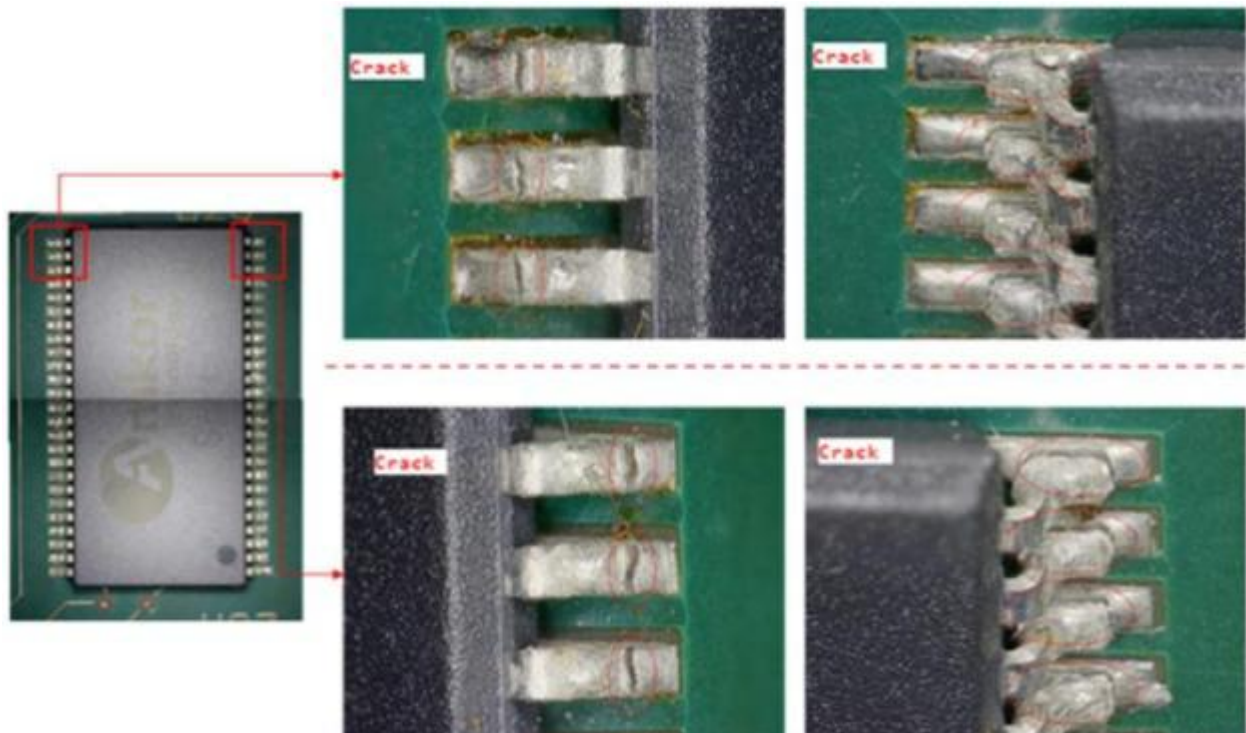
Component location U29 is a TSOP-50 soldered with SAC305 on SnPb component finish. This component failed at 161 cycles of combined environments testing.

Figure 65 - TV72 U29; Visual Inspection Showing Cracked Solder Joints

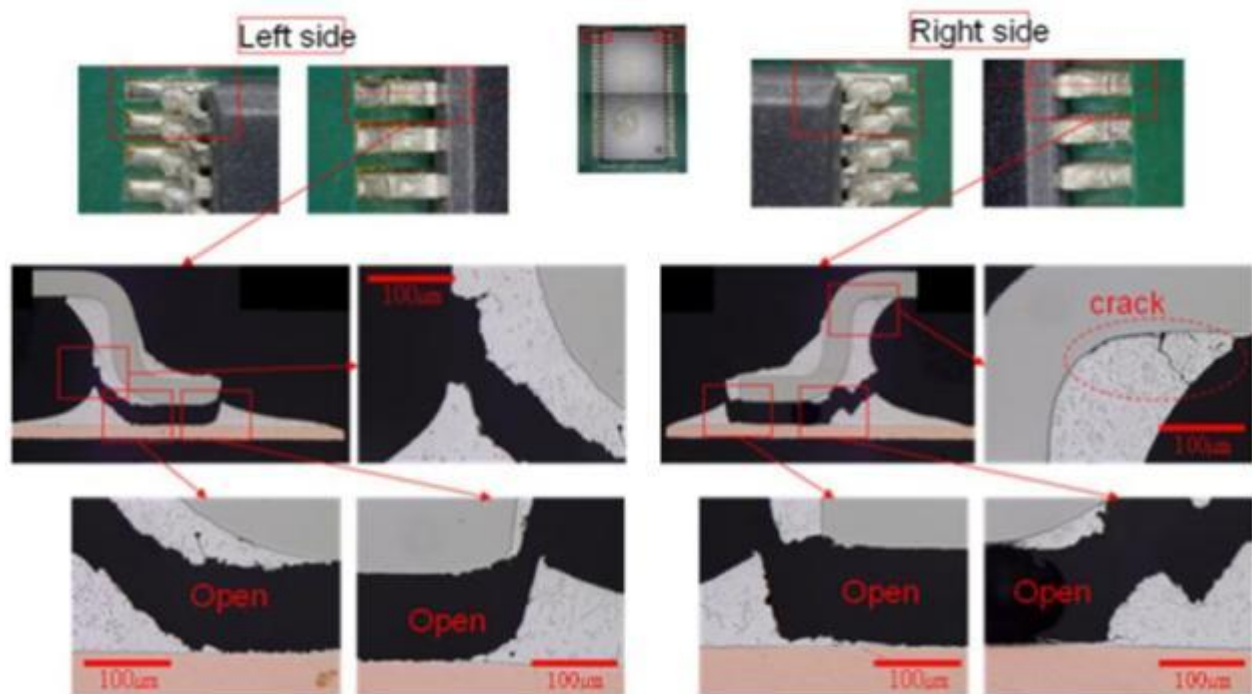
Figure 66 - TV72 U29; Cross-Section Micrographs Showing Open Solder Joints

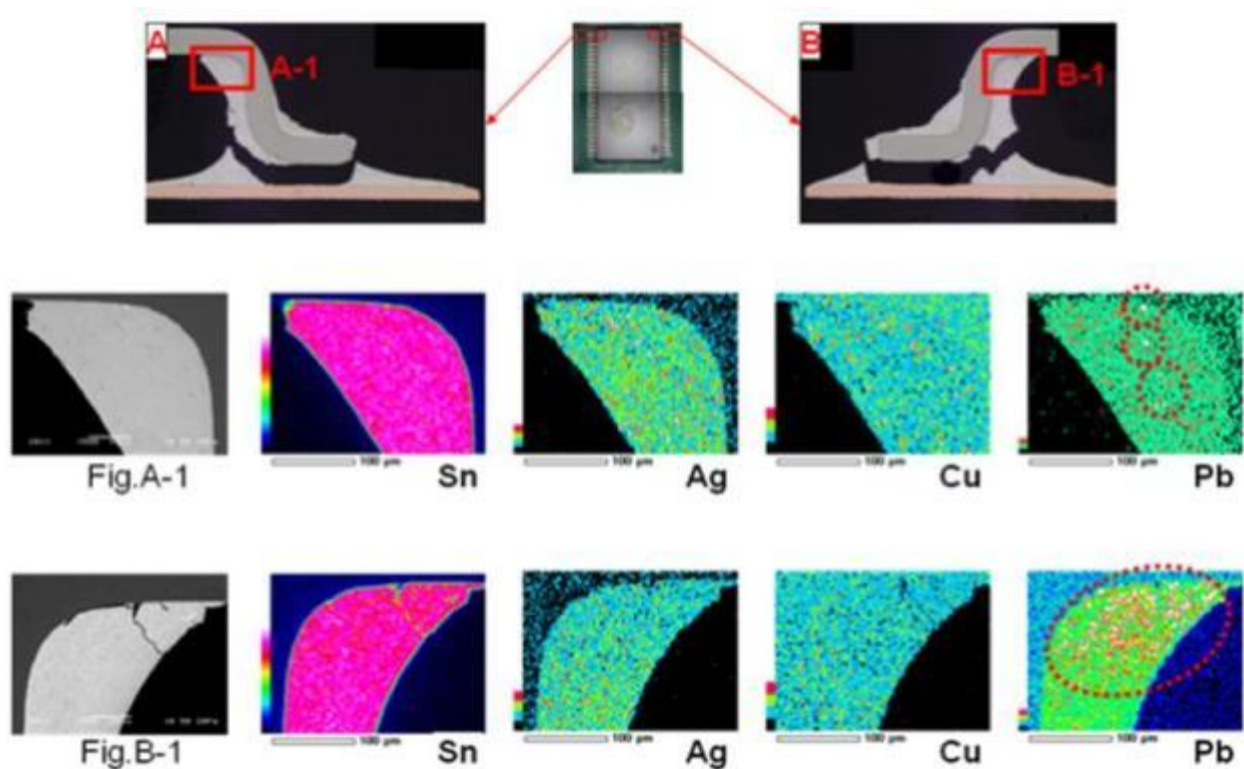
As observed in Figure 67, more Pb was found from the right lead. Source of Pb is from the lead plating.

Figure 67 - TV72 U29; SEM Mapping, Pb was Found Around Upper Part of the Both Leads

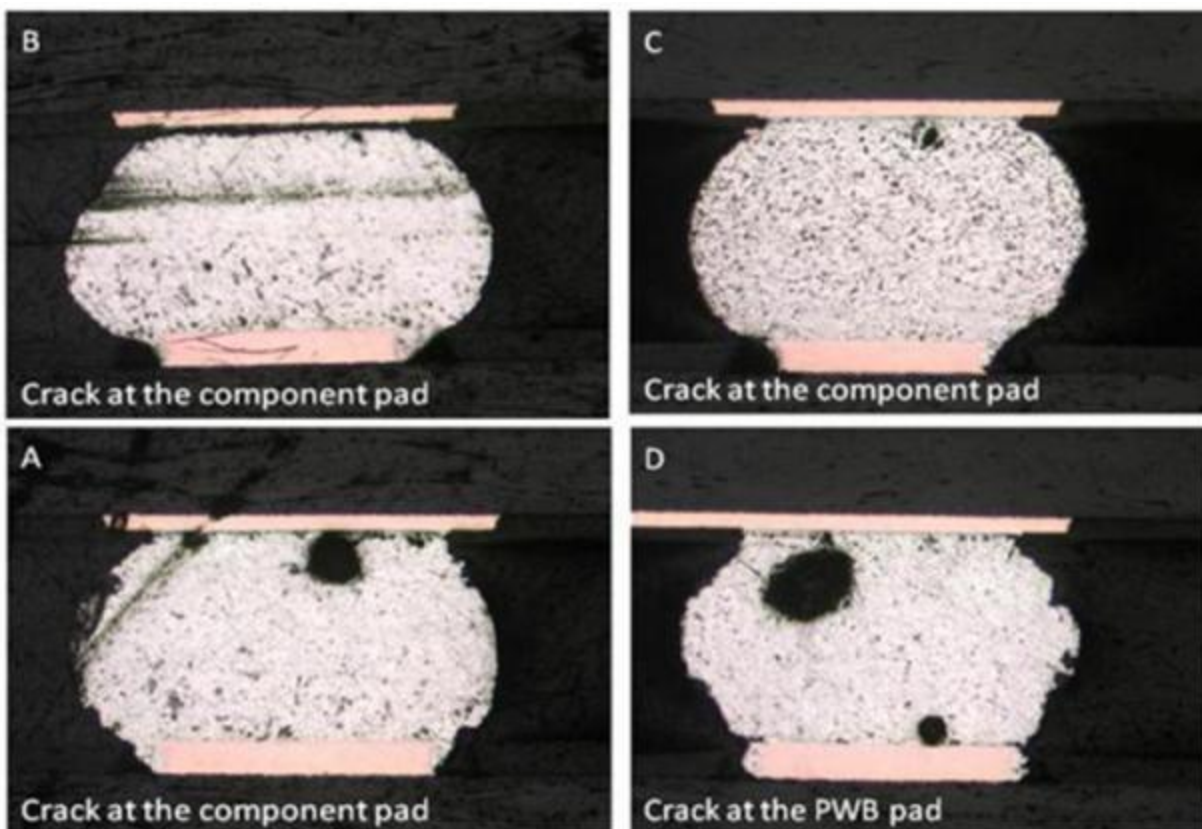
Figure 69 - TV117 U4; Cross-Sectional Micrographs of Corner Solder Balls

Figure 69 shows cross-sectional micrographs of corner solder balls depicting cracks at component pads on views A, B and C. Crack at the PWB pad detected on view D.

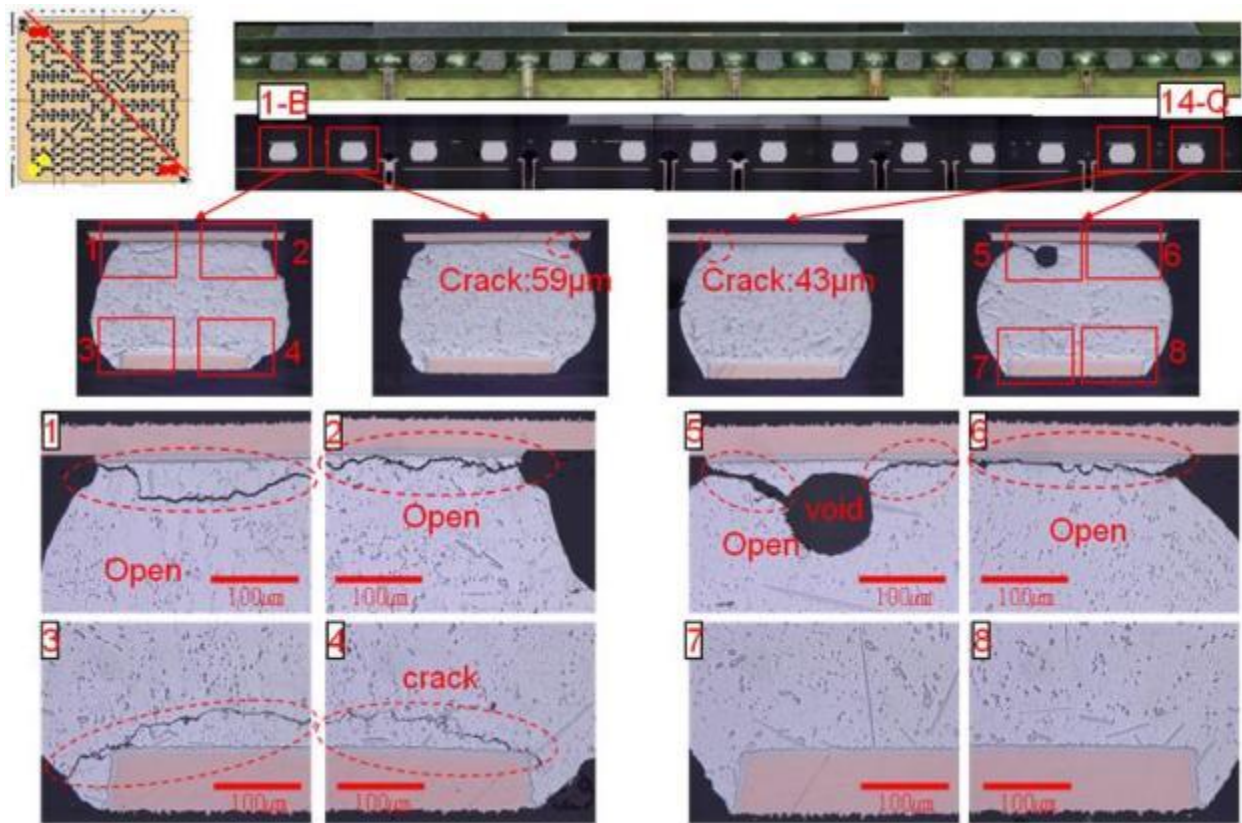
Figure 98 - TV180 U21; Cross-Sectional Micrographs

In Figure 98 the cross-sectional micrographs show cracking to opens on board side (1, 2, 5, 6).

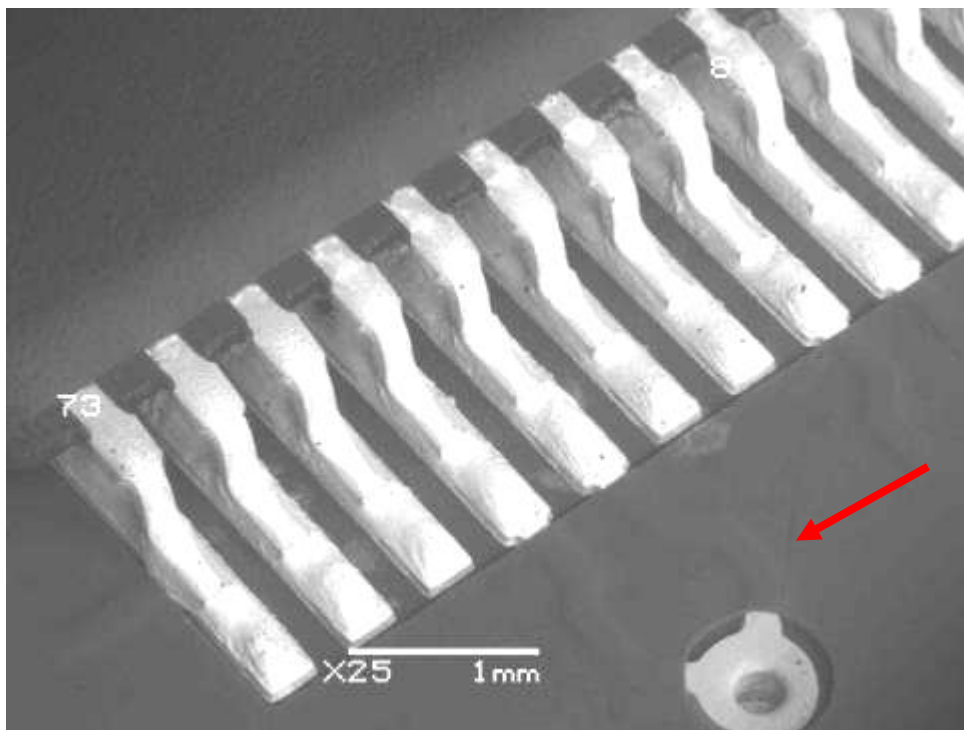
Figure 221 - U57 TQFP, SEM Image, Solder Mask Crack near Leads 73-81 (X25)

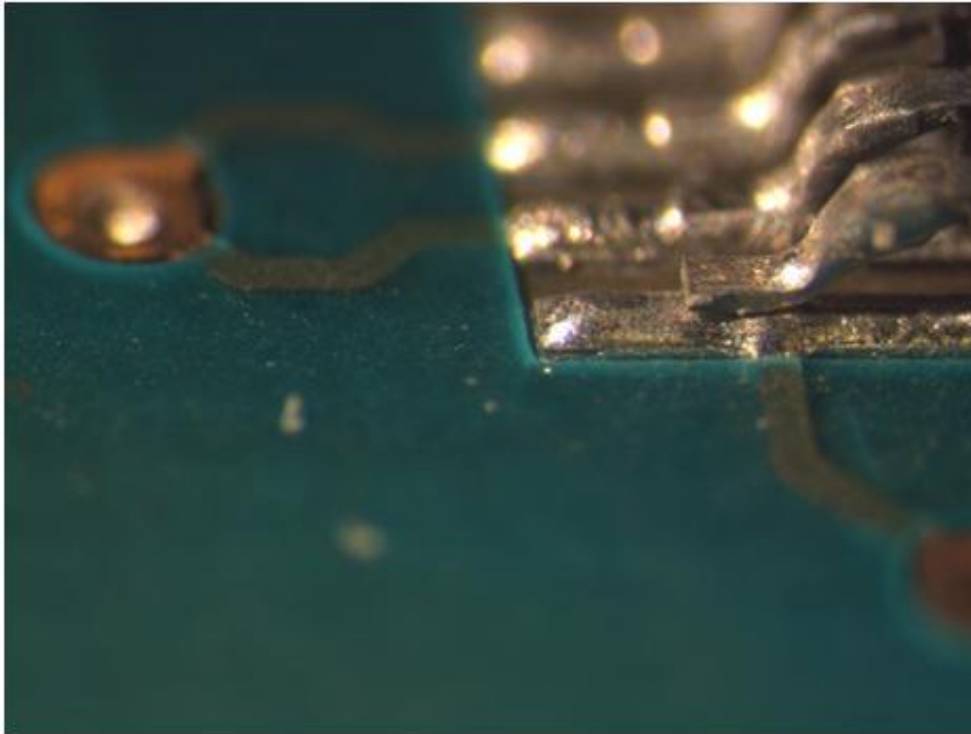
Figure 222 - U34 TQFP, Lead 72 marked (X49); Open due to Non Coplanarity

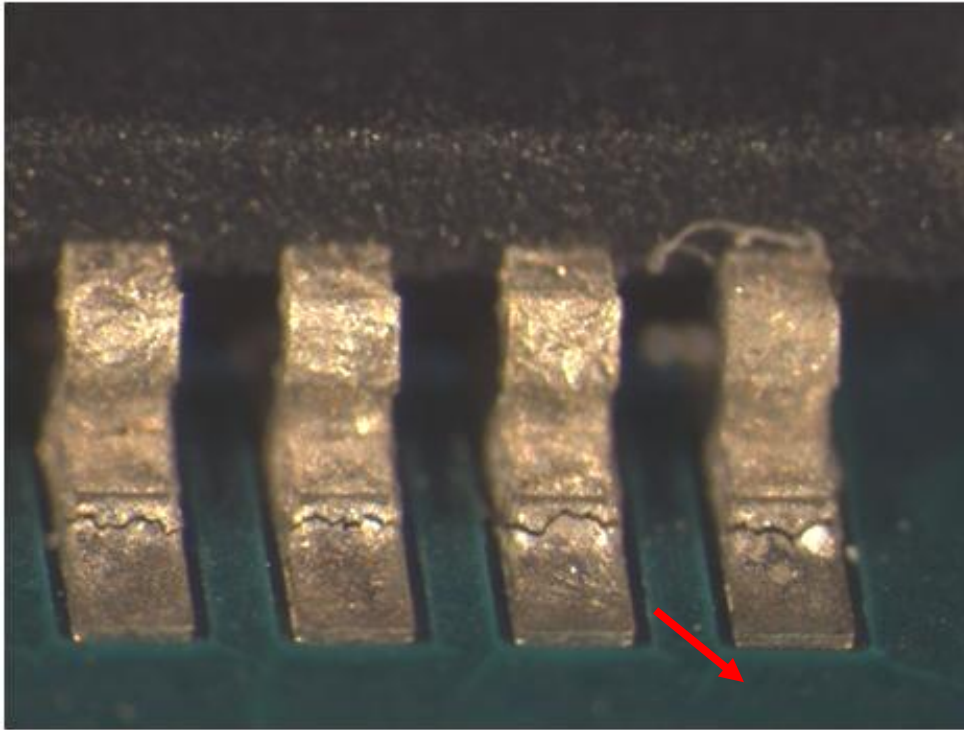
Figure 224 – U39 TSOP, Cracks in Solder Joints and Solder Mask (X49)

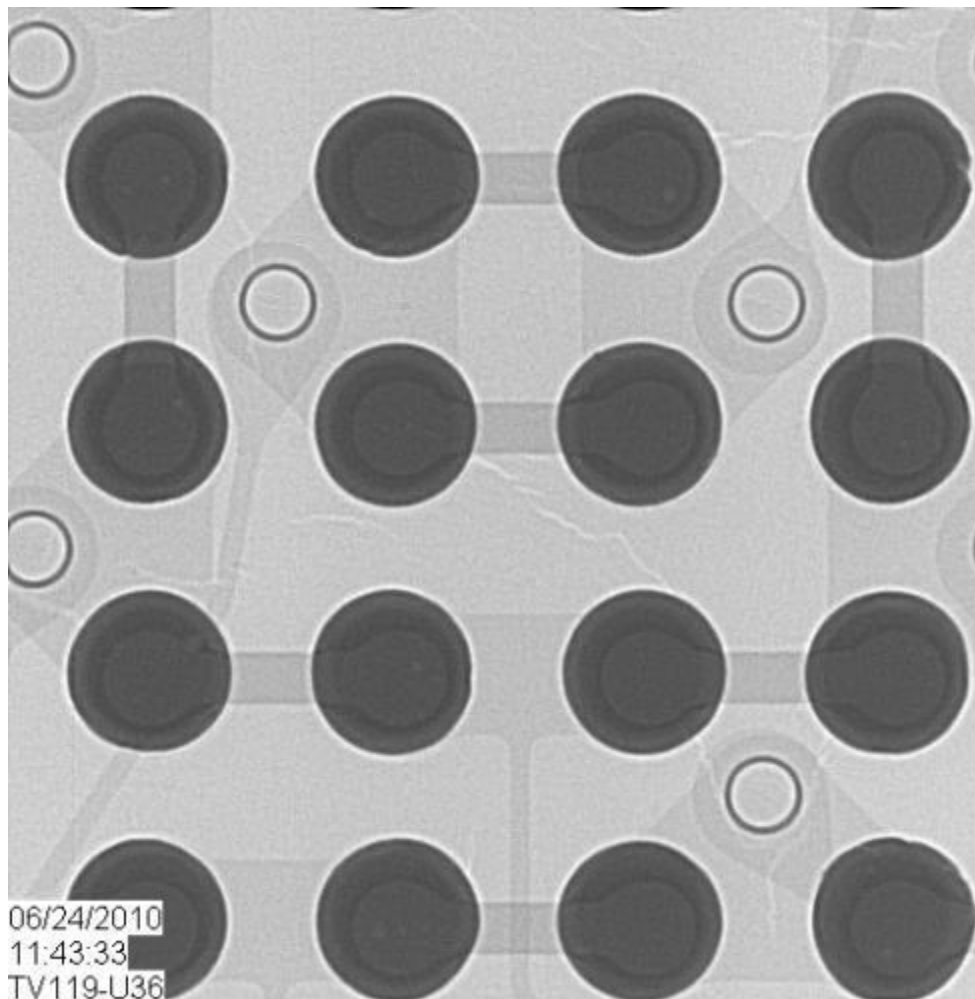
Figure 229 - U36 CSP, X-ray Image, Center Region, Solder Mask Cracks

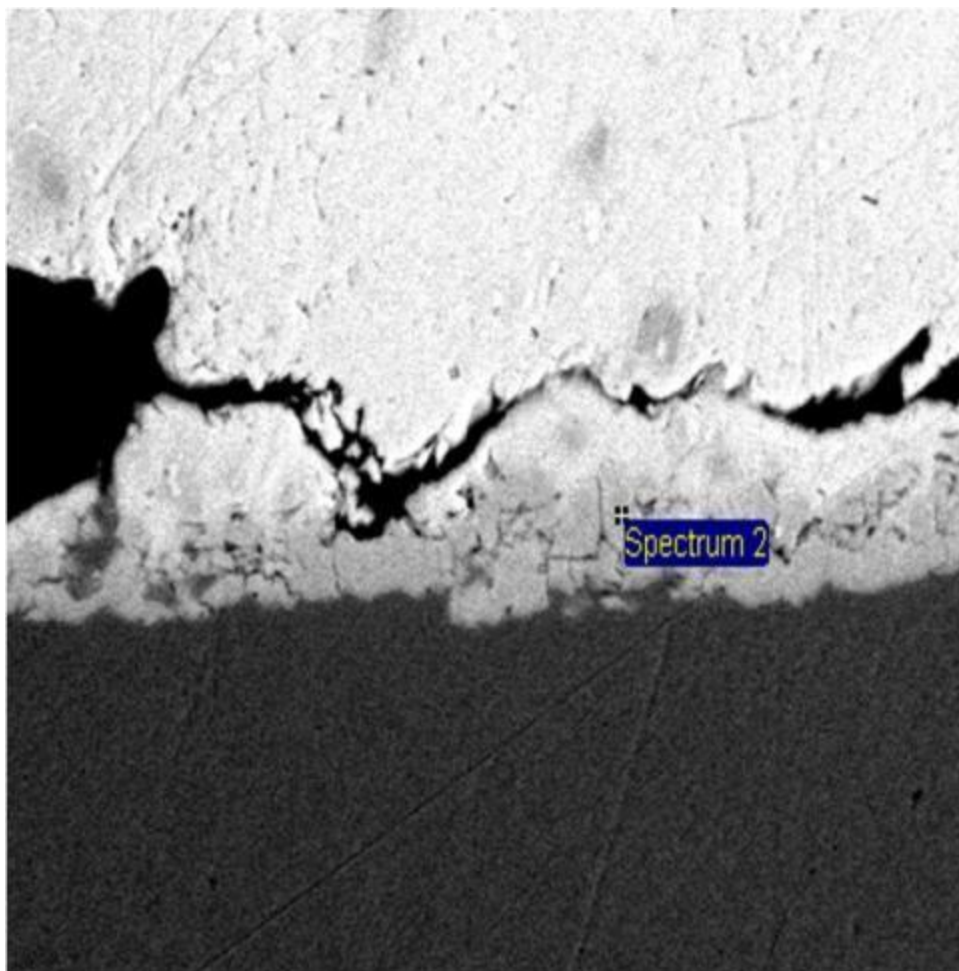
Figure 230 – U36 CSP, Solder Ball A10, PCB Side, Cracks Developed at SnCu Phase
